AIRCRAFT SERIOUS INCIDENT REPORT AND EXECUTIVE SUMMARY

Reference:	CA18/3/2/0806	
Aircraft Registration	ZS-PMY	Date of Incident	10/09/2010		Time of Incident	1245Z
Type of Aircraft	Cessna 172RG (Aeroplane)		Type of Operation		Private	
Pilot-in-command Licence Type		Commercial	Age	19	Licence Valid	Yes
Pilot-in-command Flying Experience		Total Flying Hours	246,2		Hours on Type	35,3
Last point of departure		Cape Town International Aerodrome (FACT)				
Next point of intended landing		Cape Town International Aerodrome (FACT)				
Location of the incident site with reference to easily defined geographical points (GPS readings if possible)						
Cape Town International Aerodrome, Taxiway Charlie						
Meteorological Information		Surface wind 135°/15 kt, temperature 17 °C, visibility +10 km				
Number of people on board	1 + 2	No. of people injured	0	No. of people killed	0	
Synopsis						
<p>The pilot, accompanied by two passengers, departed from Cape Town International Aerodrome on a local private flight. After being airborne for approximately one hour and forty-five minutes they returned to FACT for the landing.</p> <p>Prior to landing the pilot selected the landing gear down and normal ope

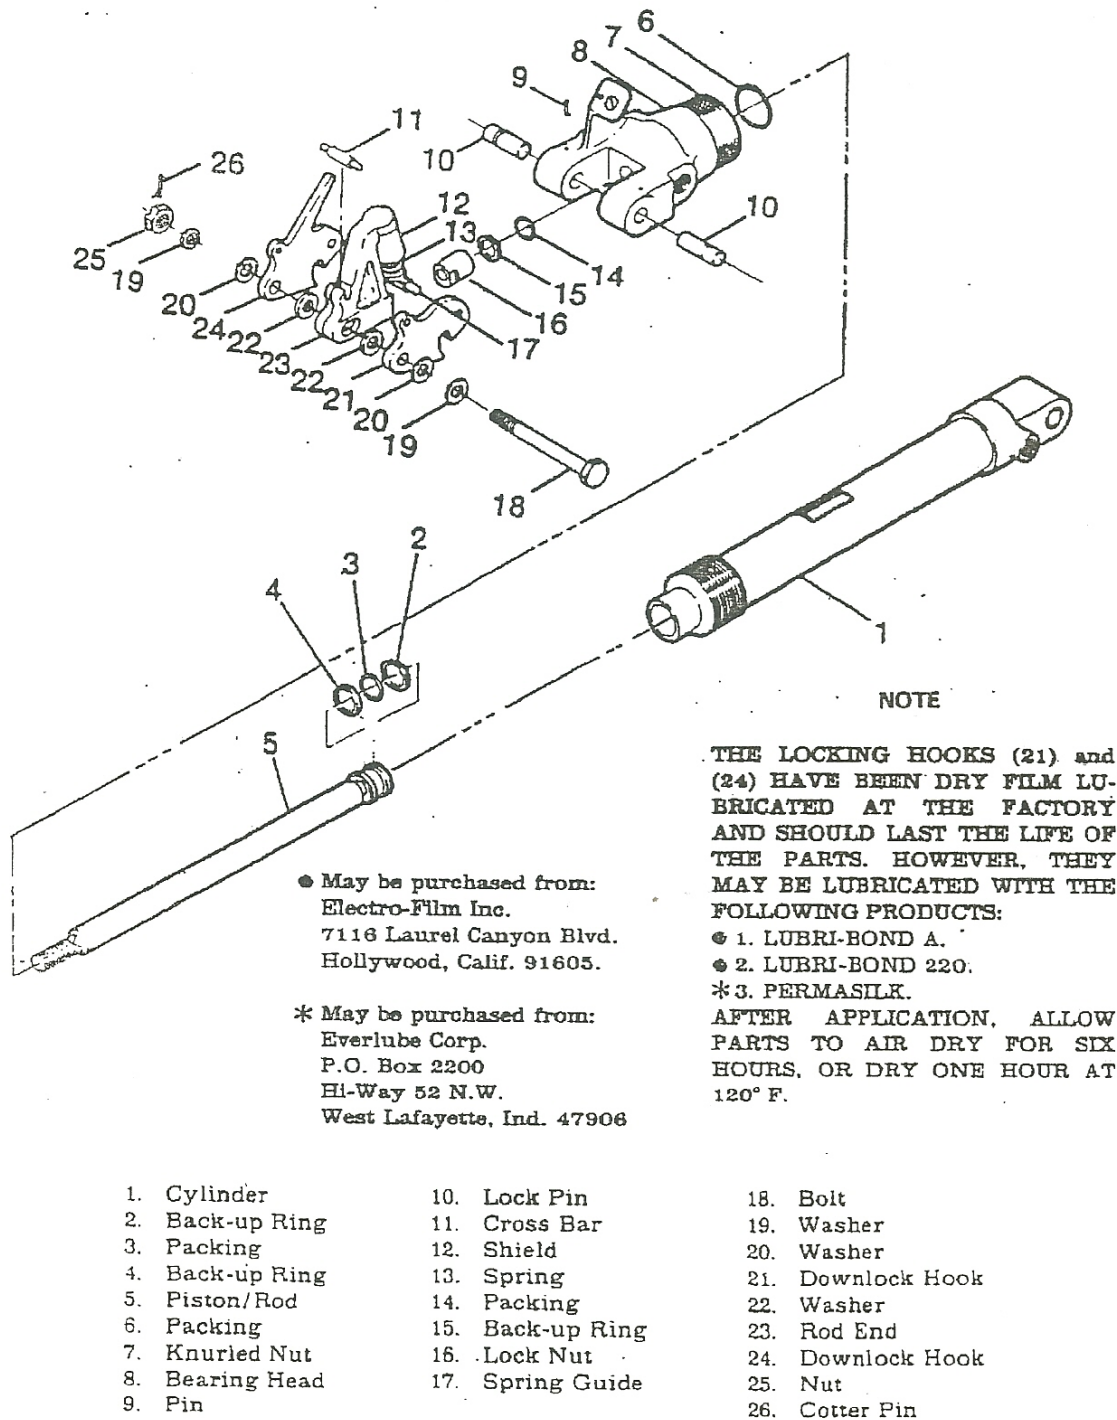
Figure 5-17. Nose Gear Actuator/Downlock Assembly

The nose gear shock strut is pivoted at the firewall. Retraction and extension of the nose gear is accomplished by a double-acting hydraulic cylinder, the forward edge of which contains the nose gear down-lock. Initial action of the cylinder disengage the down-lock before retraction begins. As the strut moves into the gear well, the forward side of the nose gear fork boss contacts an actuator assembly, causing the doors to close. The nose gear is held in the UP position by hydraulic pressure”.

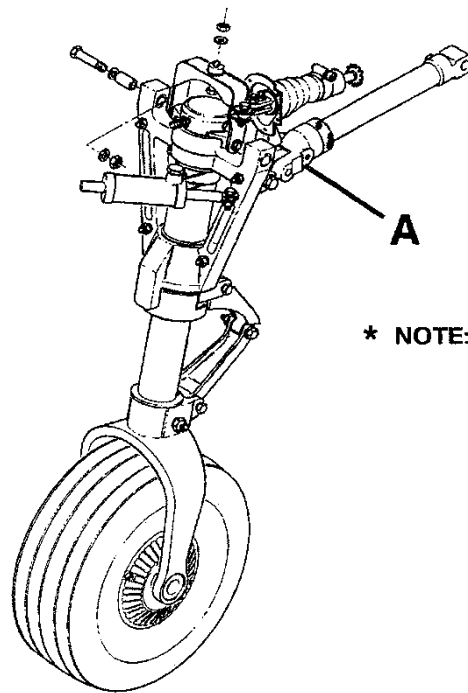
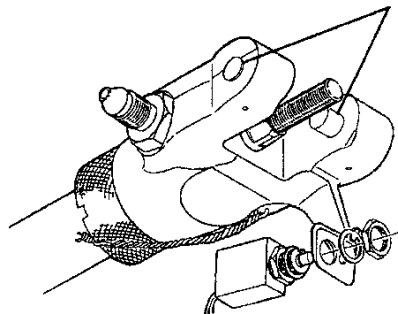
Figure 1. Down lock Actuator Pin Inspection (Sheet 1)

INSPECT ACTUATOR PINS FOR LOOSENESS OR MOVEMENT WHILE STILL ON AIRPLANE

- D. *Support nose wheel so pressure is off the actuator pins.*
- E. *(Refer to Figure 1, Sheet 1, Detail A). Visually inspect actuator pins while physically attempting to rotate and/or move actuator pins about all three axes in the bearing end. No movement is allowed, as pins are a press fit.*

- F. *If any looseness or movement is observed:*

- (1) Install SK210-55 prior to further flight.
- G. If looseness or movement is not observed, repetitive inspections of the nose gear actuator pins shall be accomplished per the compliance section of this service bulletin.
2. Make an entry in the airplane logbook stating compliance with this service bulletin and method of compliance, and if applicable, when the next inspection is due.
